APPENDIX B
SANITARY SEWER TELEVISING RECORDS

Tabular Report of PSR SA2051 5 for Village of Newberry

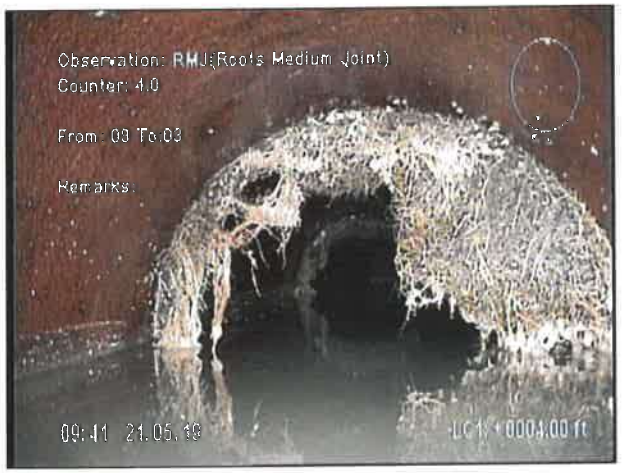
Date: 2019/05/21
Distance: 4.0 Ft
Obs: Roots Medium Joint

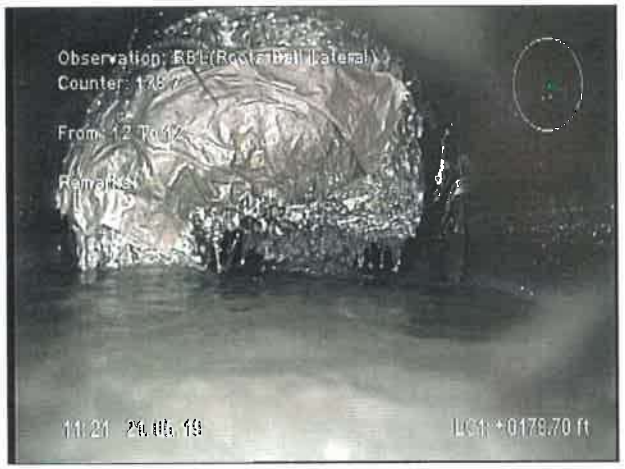
Date: 2019/05/21
Distance: 178.7 Ft
Obs: Roots Ball Joint

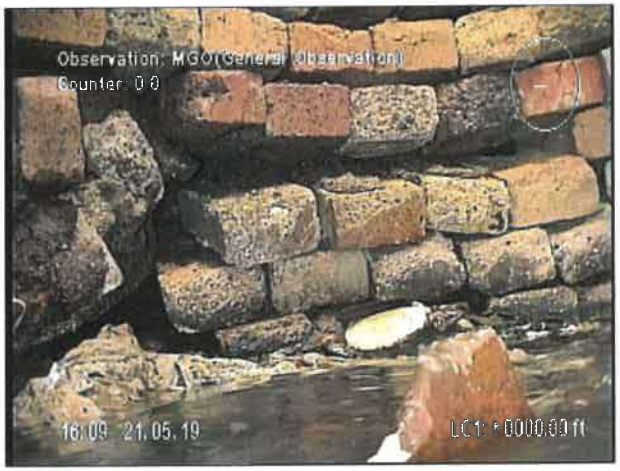
MH SA2064A
Brick construction
Square concrete cover
Cover 4" below grade
No mortar between bricks / Bricks are shifted and loose
Invert is shifted with clay pipe protruding up catching debris
No bench

Date: 2019/05/21
Distance: 0.0 Ft
Obs: General Observation

Comments:
BRICKS IN MH LOOSE

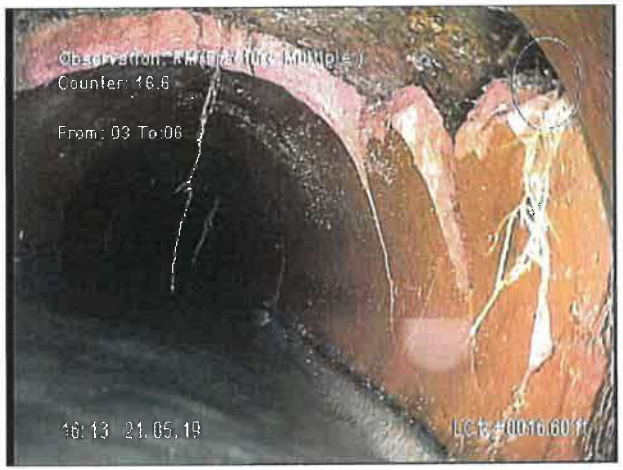
Date: 2019/05/21
Distance: 16.6 Ft
Obs: Fracture Multiple
